Re: October 2013 Monthly Progress Report
Administrative Settlement Agreement and Order on Consent for Removal Action
U.S. EPA Region 10 Docket No. CERCLA 10-2009-0255
Gasco Sediments Site within the Portland Harbor Superfund Site

Attachment A Monthly Visual Monitoring Report for Pilot Cap Vicinity

Visual Observations Log Form

Monitoring Period: Monthly (Year 7)—October 2013

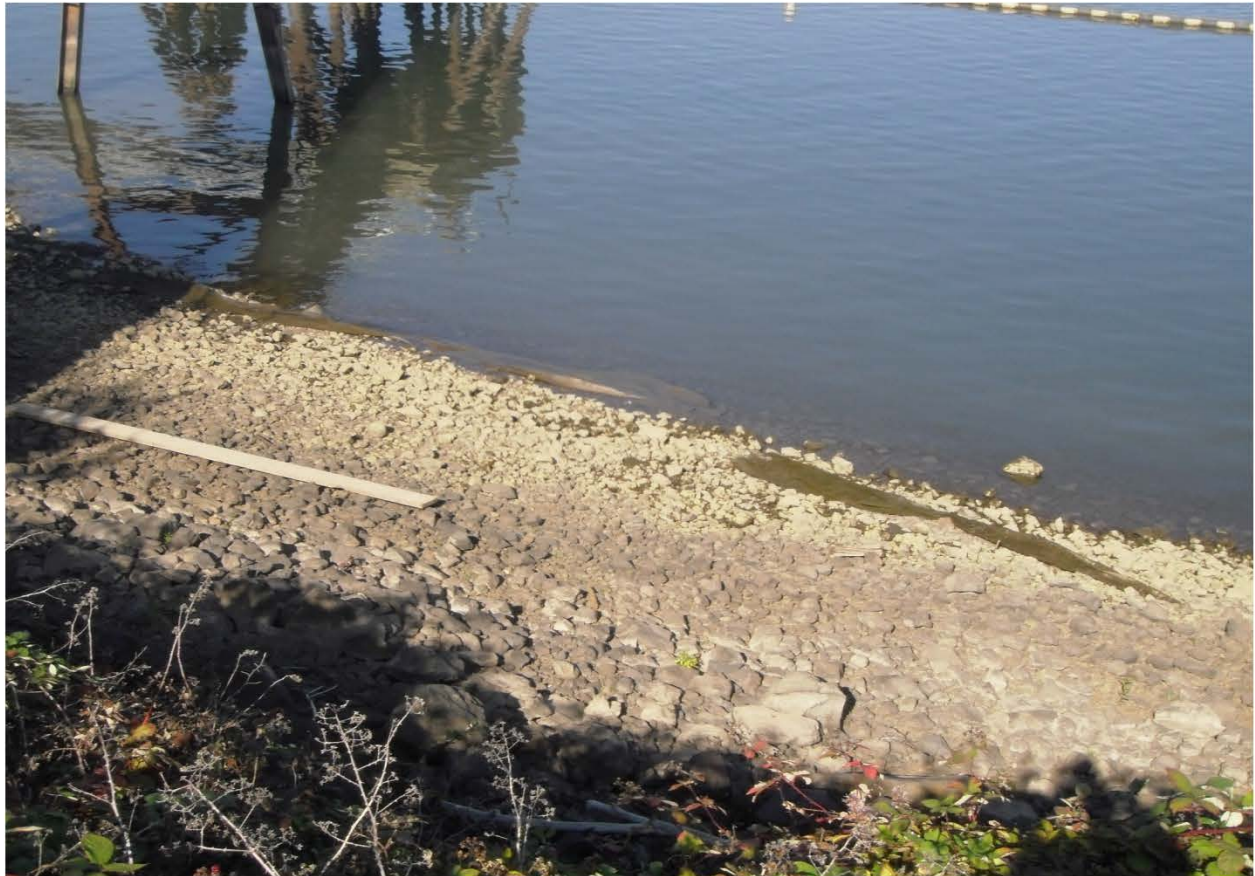
Photo 1 — *Visible section of organo-clay mat near the downriver extent of the cap area (10/17/13):*

Observations of Erosion/Deposition: No erosion/deposition is evident along the shoreline. Three organoclay mat material segments are exposed and visible. Fifteen feet of a 20-foot section of organoclay mat is out of the water at the upriver extent of the cap area perpendicular to the shoreline. A segment measuring 4-foot in length is 10 feet from shoreline near the lateral mid-point of the cap area. One 40-foot section of organoclay mat material is exposed and most is out of the water or at the shoreline near the downriver extent of the cap area (Photo 1).

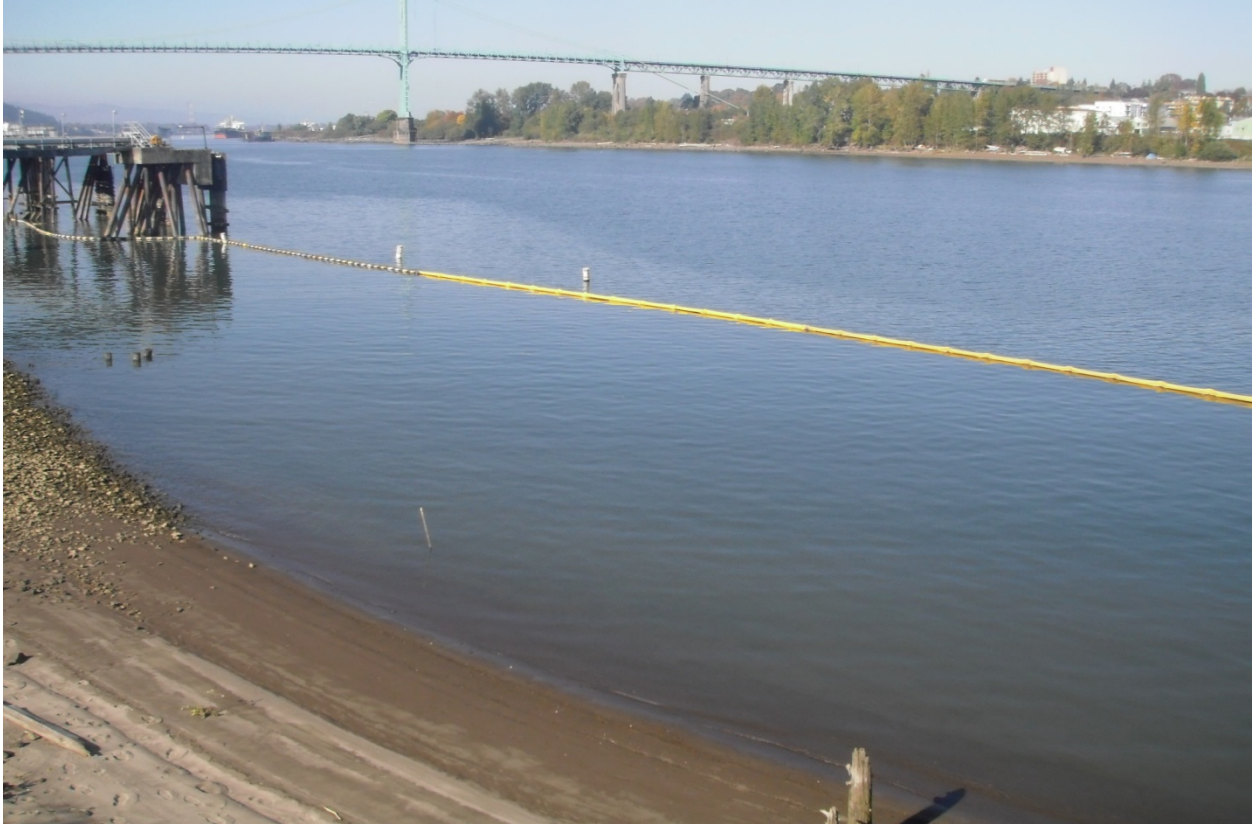
Photo 2 — *FAMM oil boom and mariner warning buoys across pilot cap area. (10/17/13):*

Observations of Long-term Controls (i.e., oil booms, organo-clay mat, etc.) During the observation, the Fuel and Marine Marketing (FAMM) containment boom was placed across the cap area, between the upriver corner of the ship dock and the wooden dolphin (near the upriver extent of the site and near the Siltronic Corporation outfall). Buoys that identify the cap area to mariners are in place as installed. The position of the FAMM oil boom, warning buoys, and a general overview is shown in Photo 2.

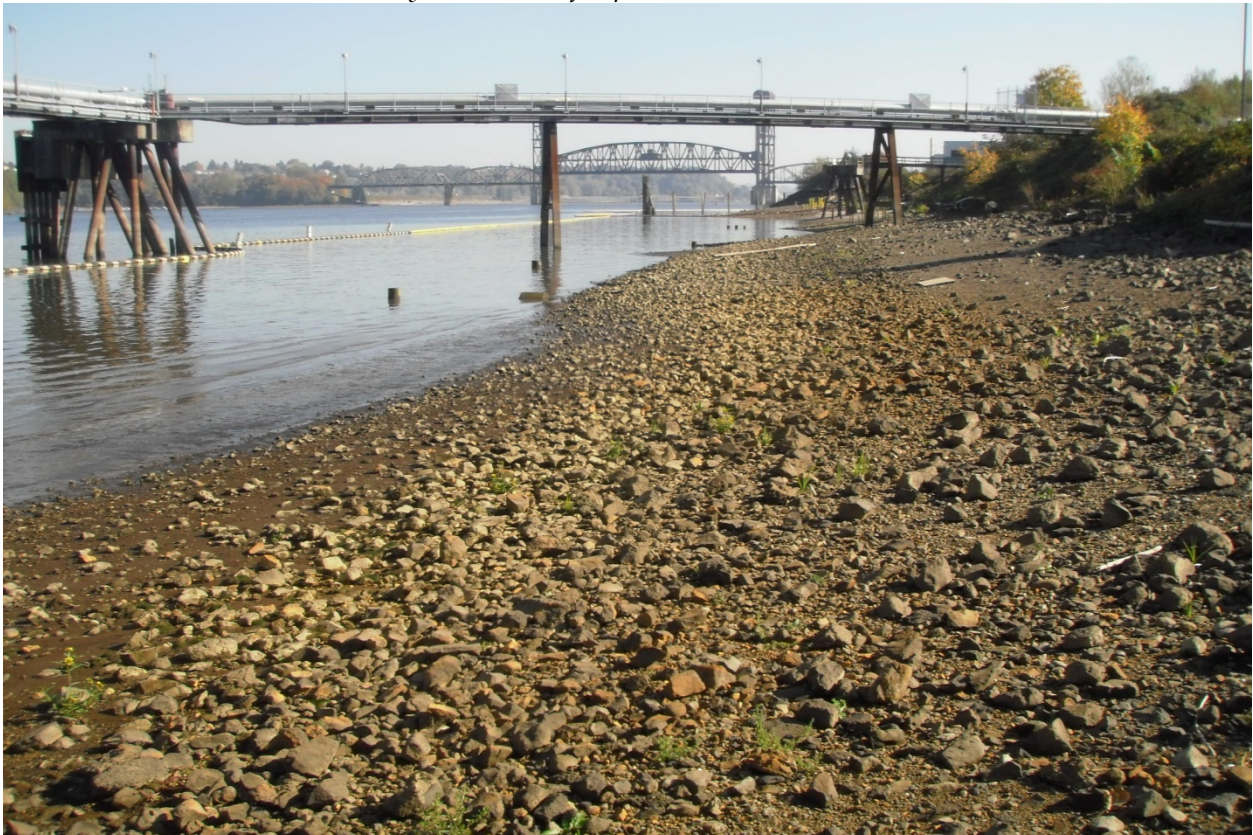
Photo 3 — *Conditions immediately downriver of cap area (10/17/13):*

No sheen is evident in or around the cap area. Photo 3 shows the water surface and shoreline immediately downriver of the sediment cap.
